RE: Repair Designs for the Lower Section of Reclamation Channel SD-6,  
Gordon Creek 2, 7, and 8 Mines, Permit # C/007/0016

#### Revised Plan for Repair of Reclamation Channel SD-6 at the Gordon Creek 2, 7, 8 Mines, Carbon County, Utah

# **Revised Plan for Repair of Reclamation Channel SD-6 at the Gordon Creek 2, 7, 8 Mine, Carbon County, Utah**

Revised SD-6 Channel Repair Plan  
October 5, 2015

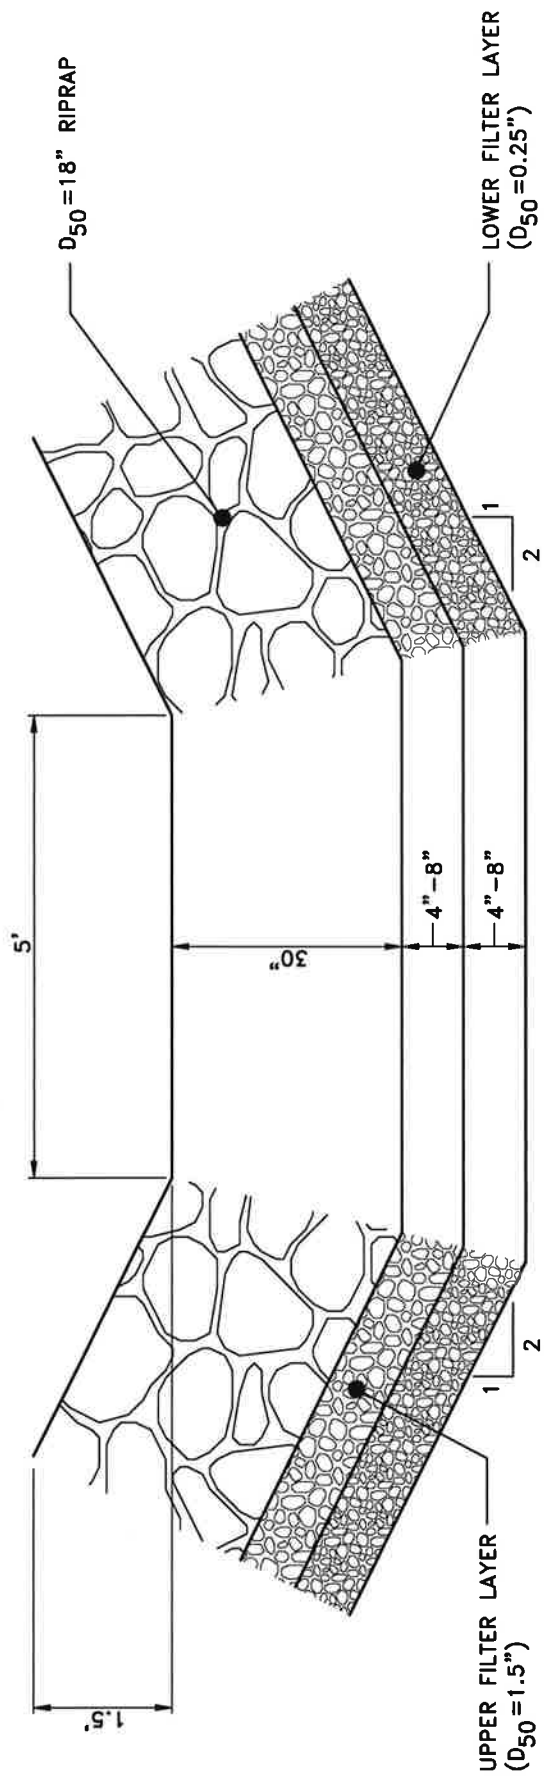
FIGURE 1. REPAIRED RECLAMATION CHANNEL SD-6 CROSS SECTION

Consistent with the recommendations of Brown and Clyde (1989), each filter layer will be placed to a thickness of 4 to 8 inches. The resulting cross section of the lower portion of reclamation channel SD-6 is shown in Figure 1.

Only the lower of channel SD-6 will require repair. In accordance with the above calculations, the channel will be replaced as indicated on Figure 1. The basic plan for repair of the channel is as follows:

- Mobilize equipment and materials to the site and install sediment controls as necessary.
- Recover riprap and filter material that has accumulated at the downstream end of the channel for re-use as appropriate.
- Regrade the lower section of the damaged channel, as necessary, to fill eroded sections and achieve the required grades.
- Install the lower filter bedding ( $D_{50}=0.25$  inch) to a depth of 4 to 8 inches.
- Install the lower filter bedding ( $D_{50}=1.5$  inches) to a depth of 4 to 8 inches.
- Install  $D_{50} = 18$  inch riprap to a depth of 30 inches.
- Revegetate all areas disturbed by this project.

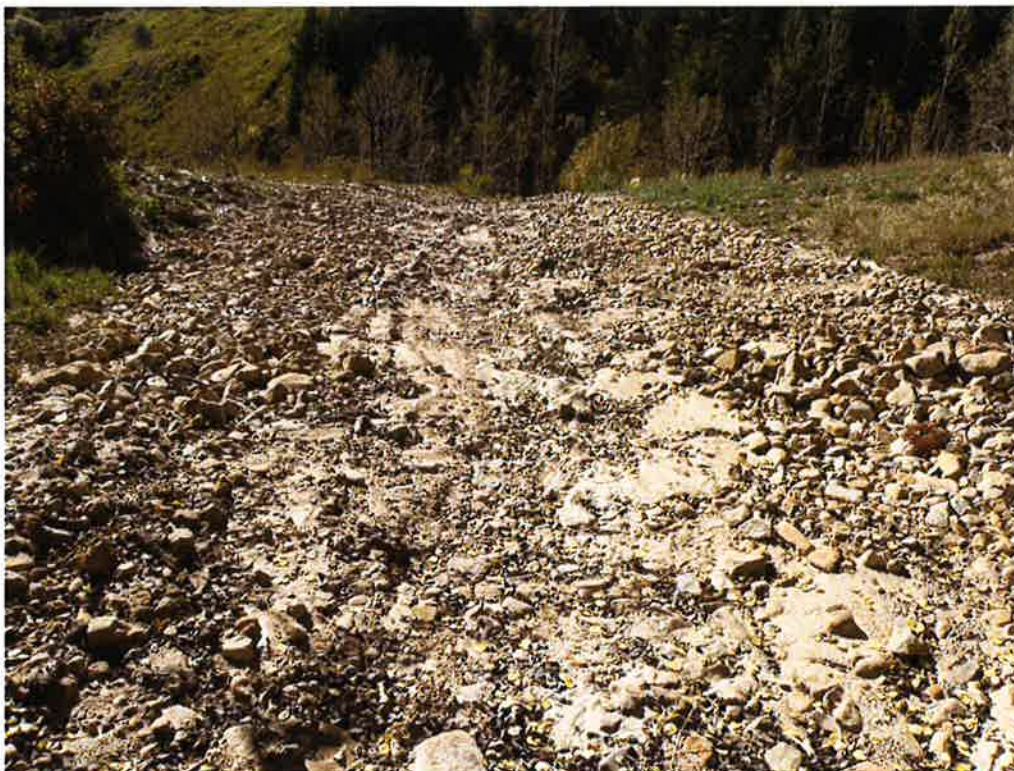
Upper (mild slope) section of SD-6. Note lack of erosion.

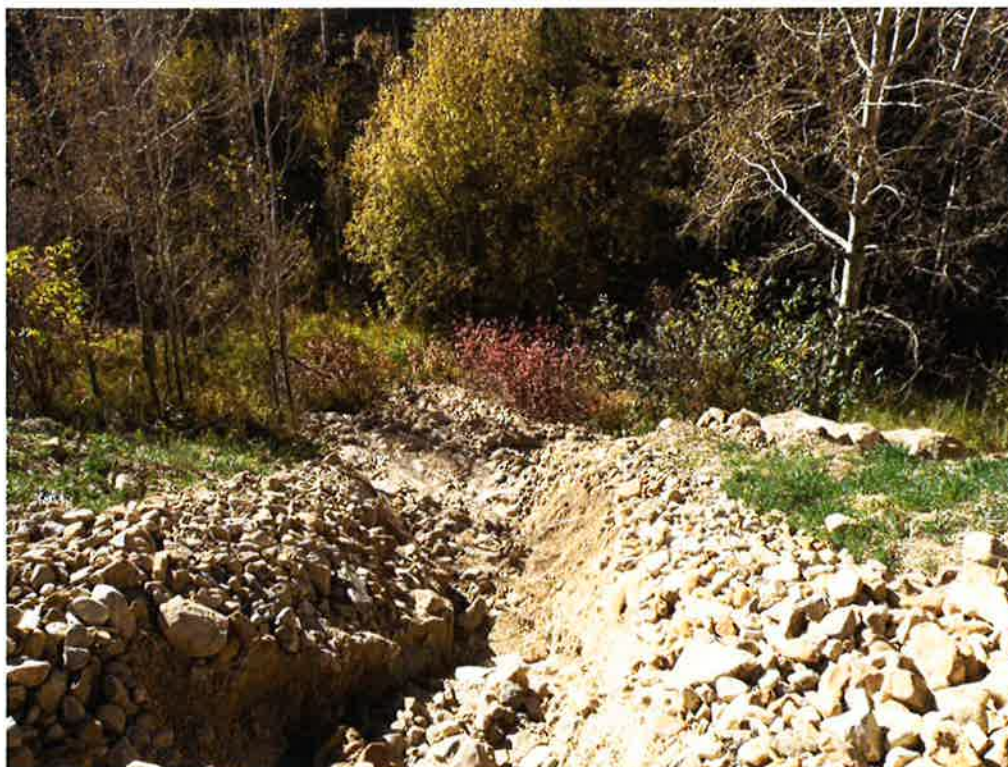
A high-intensity precipitation event in September 2014 caused substantial erosion of channel SD-6 and other reclamation channels at the Gordon Creek 2,7,8 Mine in Carbon County, Utah. As a result, these channels were reconstructed to their original design. Another high-intensity event in the summer of 2015 resulted in erosion of the riprap lining in the downstream (steeper) section of channel SD-6. The upper section of channel SD-6, with a milder slope, was not damaged by the recent event. Photographs of the 2015 erosion are provided in Attachment A. As a result of the most recent erosion, the decision was made to re-evaluate the original design approach prior to repairing the channel.

Downstream view of eroded (steep slope) section of SD-6

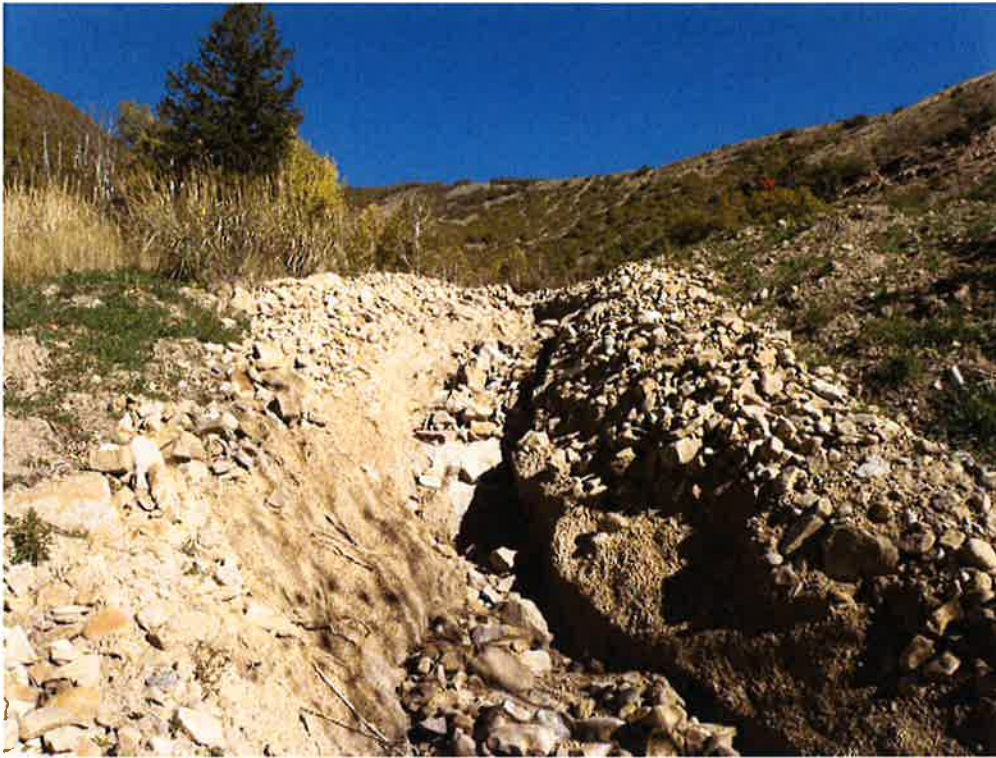
Upstream view of eroded (steep slope) section of SD-6

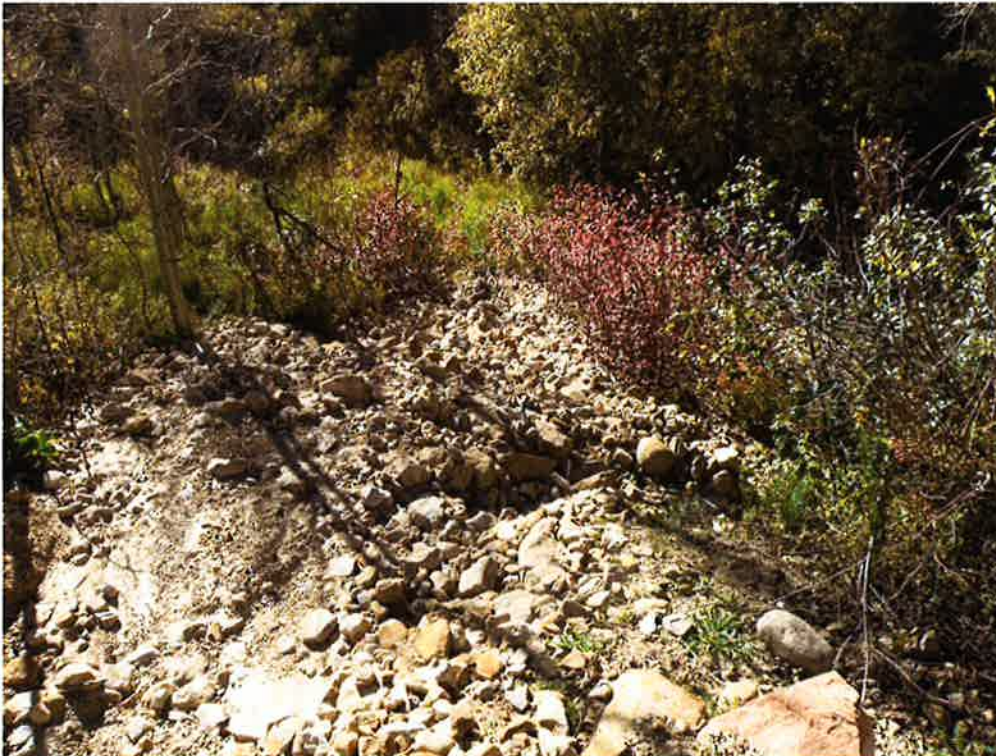
Eroded material collected at the bottom of SD-6

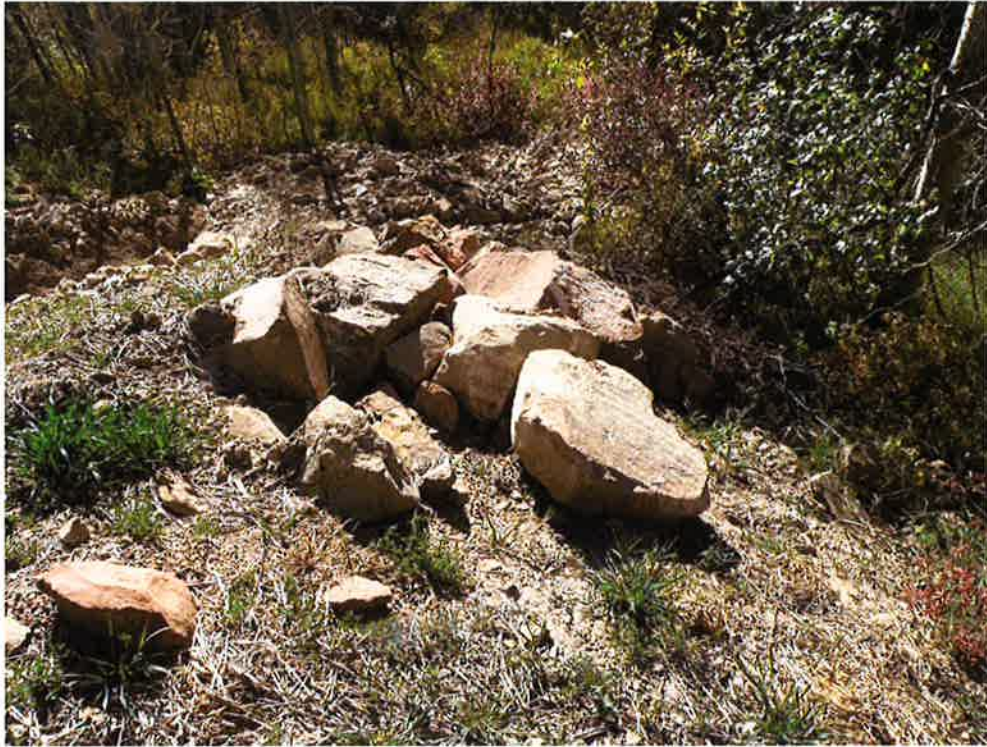
Rock adjacent to downstream end of SD-6, potentially available for use as riprap

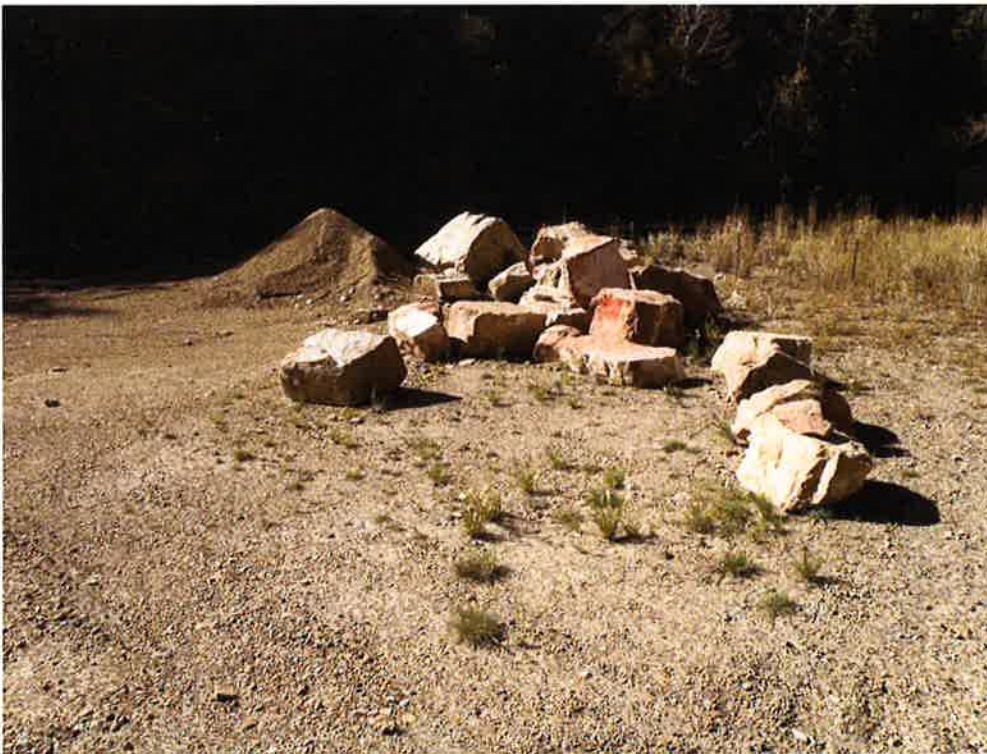
Rock and fine filter material at site entrance, potentially available for use in channel repair
